DEPARTMENT OF TRANSPORTATION

Contract #: 04-0120F4Cty: SF/ALA Rte: 80 PM: 13.2/13.9File #: 69.28**WELDING INSPECTION REPORT****Resident Engineer:**Siegenthaler, Peter**Address:** 333 Burma Road**City:** Oakland, CA 94607**Report No:** WIR-019905**Date Inspected:** 25-Jan-2011**Project Name:** SAS Superstructure**OSM Arrival Time:** 700**Prime Contractor:** American Bridge/Fluor Enterprises, a JV**OSM Departure Time:** 1900**Contractor:** Zhenhua Port Machinery Company, Ltd (ZPMC), Changxing Island **Location:** Shanghai, China**CWI Name:** Liu fa wen**CWI Present:** Yes No**Inspected CWI report:** Yes No N/A**Rod Oven in Use:** Yes No N/A**Electrode to specification:** Yes No N/A**Weld Procedures Followed:** Yes No N/A**Qualified Welders:** Yes No N/A**Verified Joint Fit-up:** Yes No N/A**Approved Drawings:** Yes No N/A**Approved WPS:** Yes No N/A**Delayed / Cancelled:** Yes No N/A**Bridge No:** 34-0006**Component:** Orthotropic Box Girder (OBG)**Summary of Items Observed:**

WELDING INSPECTION REPORT

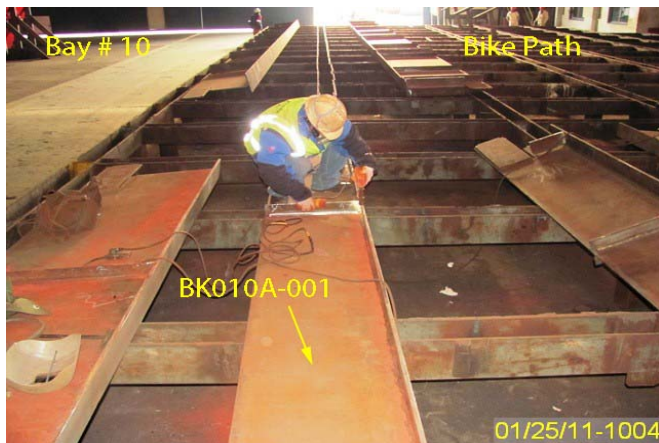
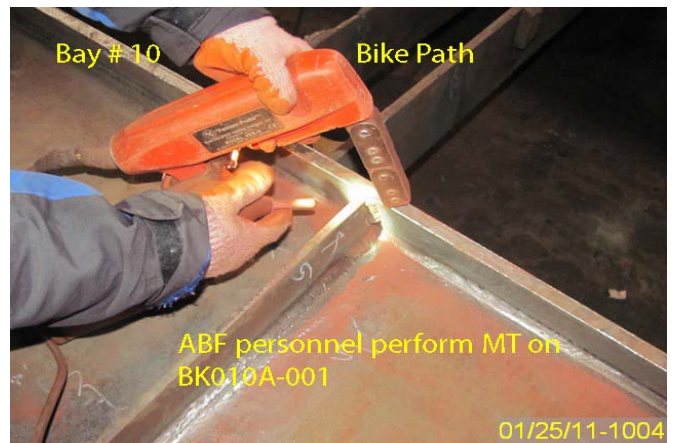
This QA inspector observed that ABF personnel perform Magnetic particle Testing (MT) on Bike Path identified as BK010A-001. See attached pictures.
